The Growing & Evolving Benefits of Stream Restoration

From Resiliency to
Stormwater BMPs –
How Will the Industry
Continue to Adapt?

J. George Athanasakes
October 30, 2018

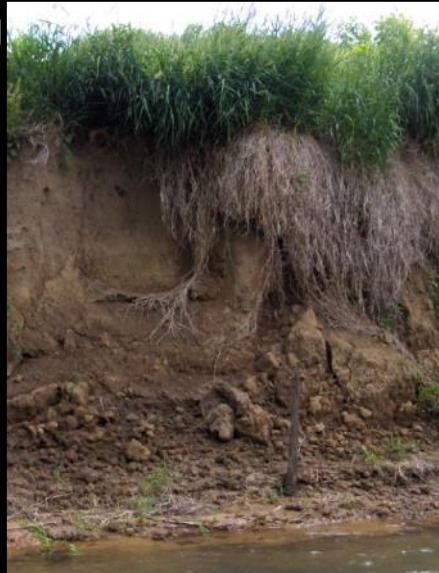
1 - Credit for Preventing Sediment Loss During Storm Flows

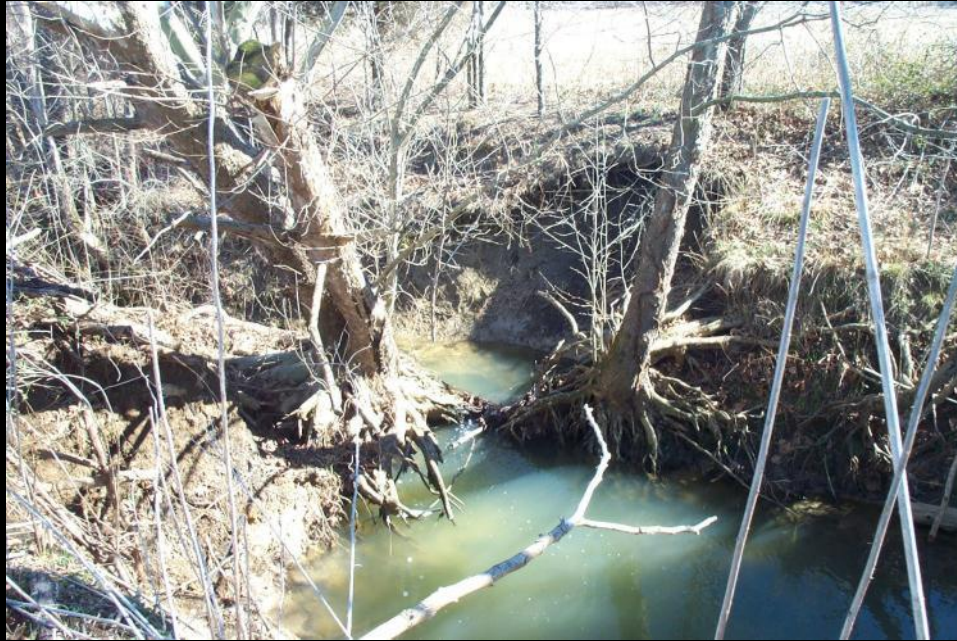
Use of Rosgen's Classification System to Predict Channel Evolution

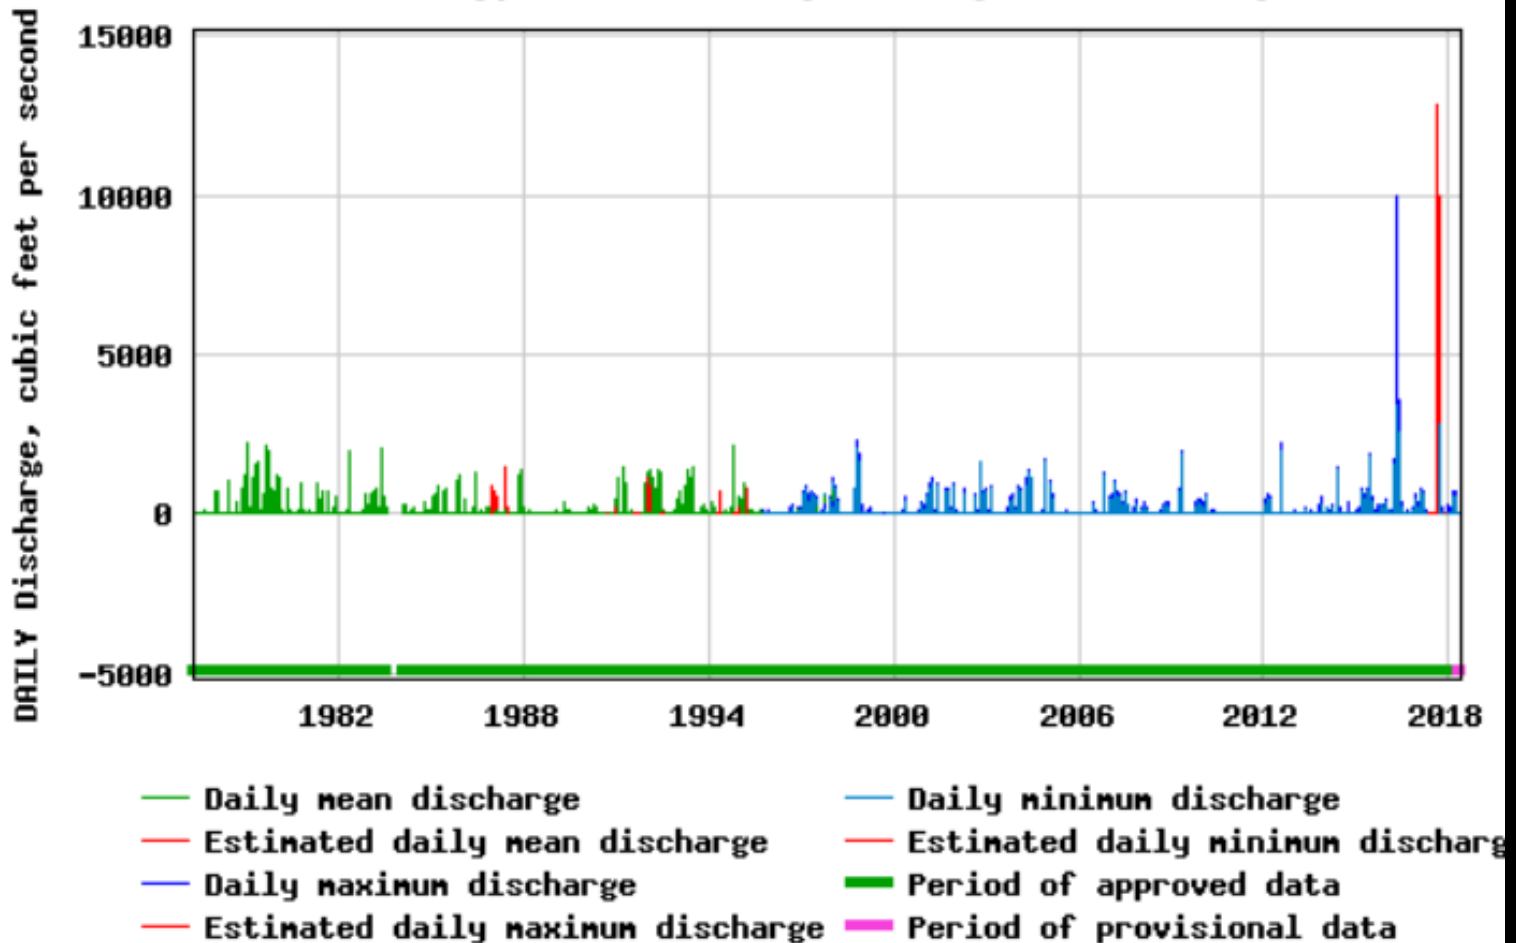
Daily Discharge 1976 - 2017

USGS 08068720 Cypress Ck at Katy-Hockley Rd nr Hockley, TX

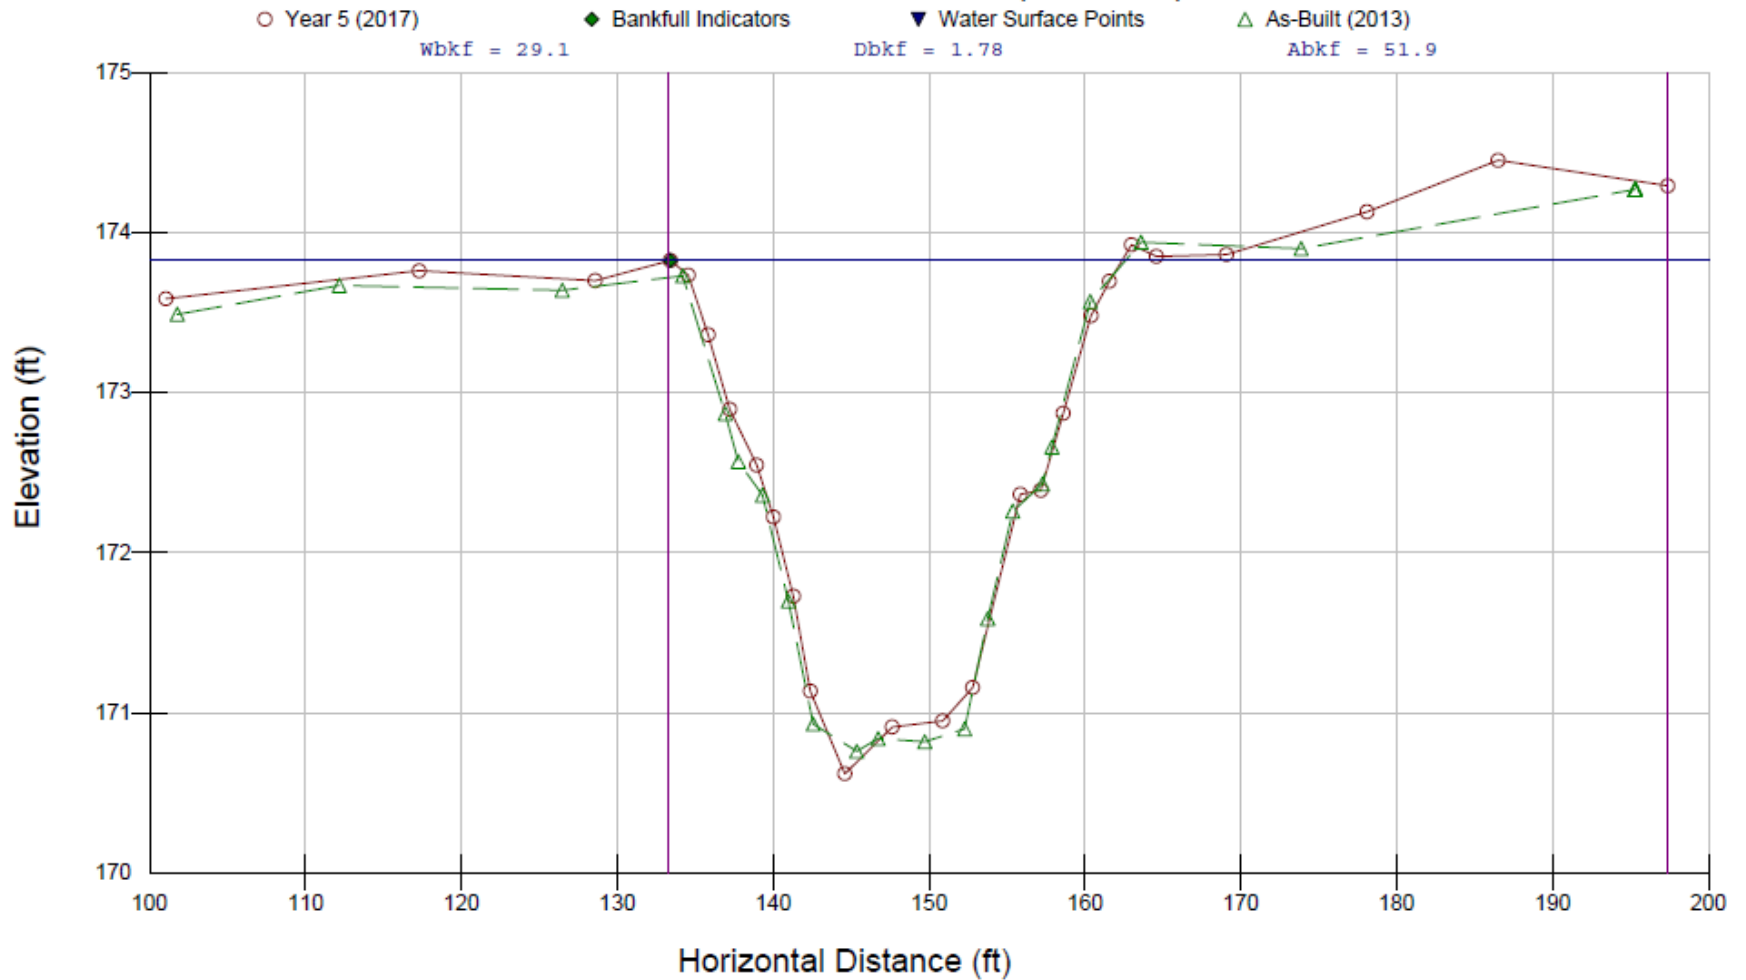
Warren Creek XS 1 Riffle (108+20)

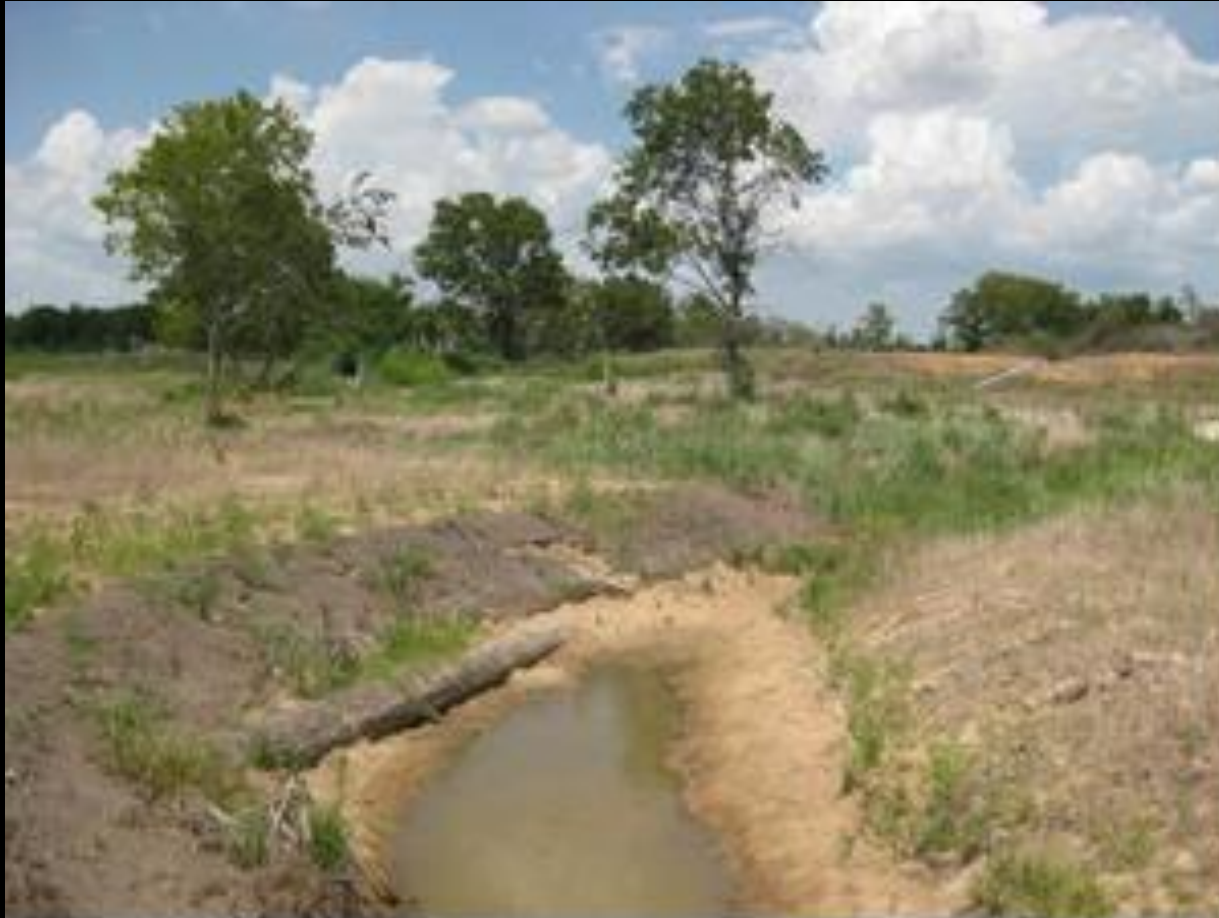
Photos Station 1 – As-Built Survey

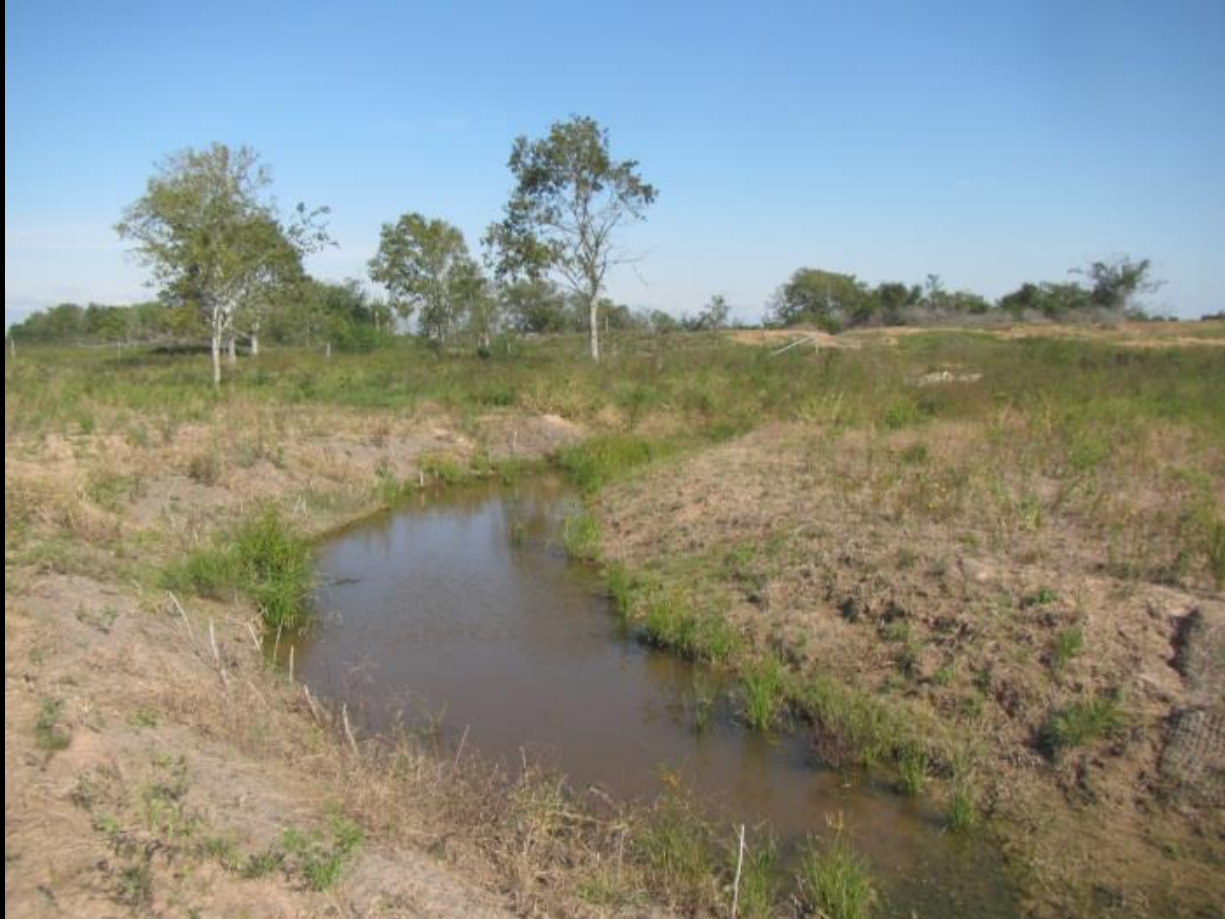
Photos Station 1 – 2013

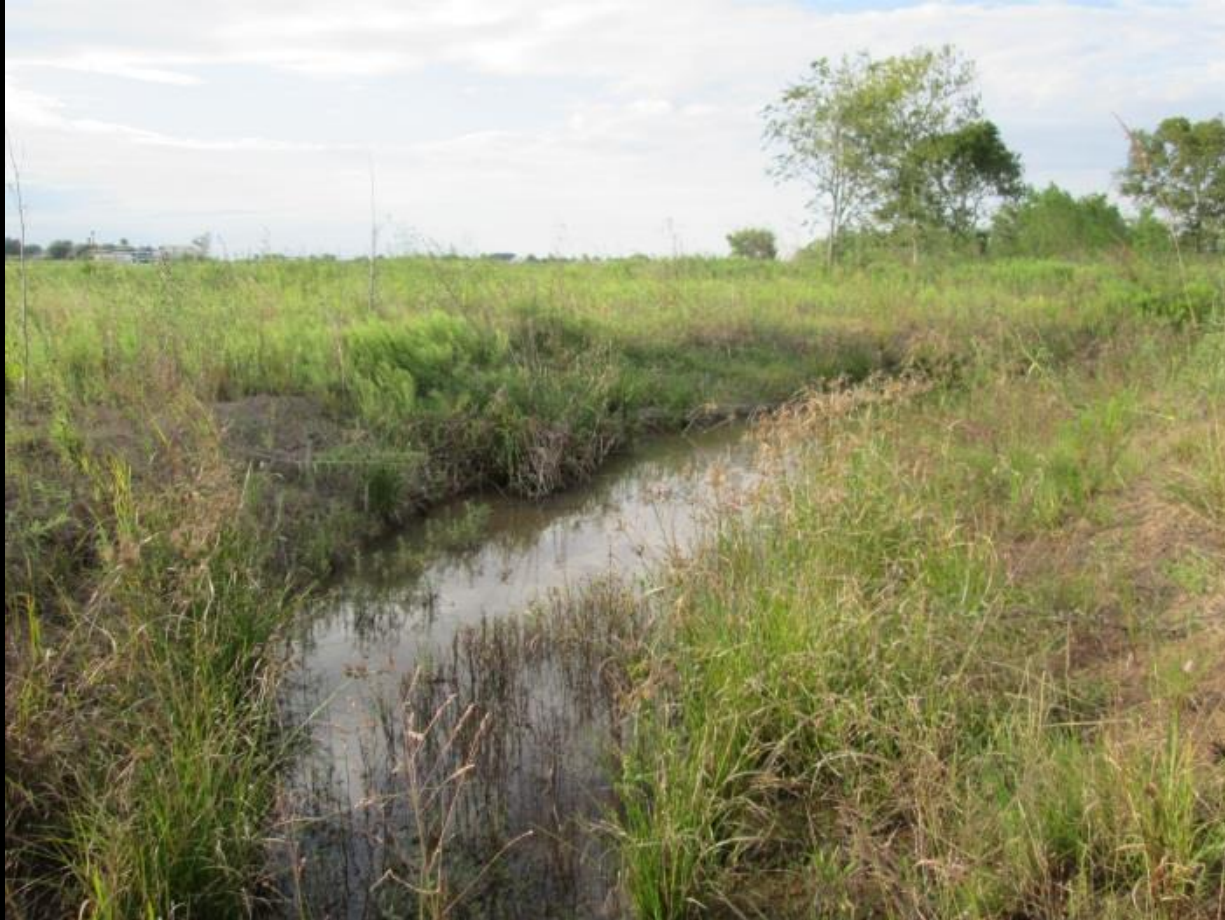
Photos Station 1 – 2014

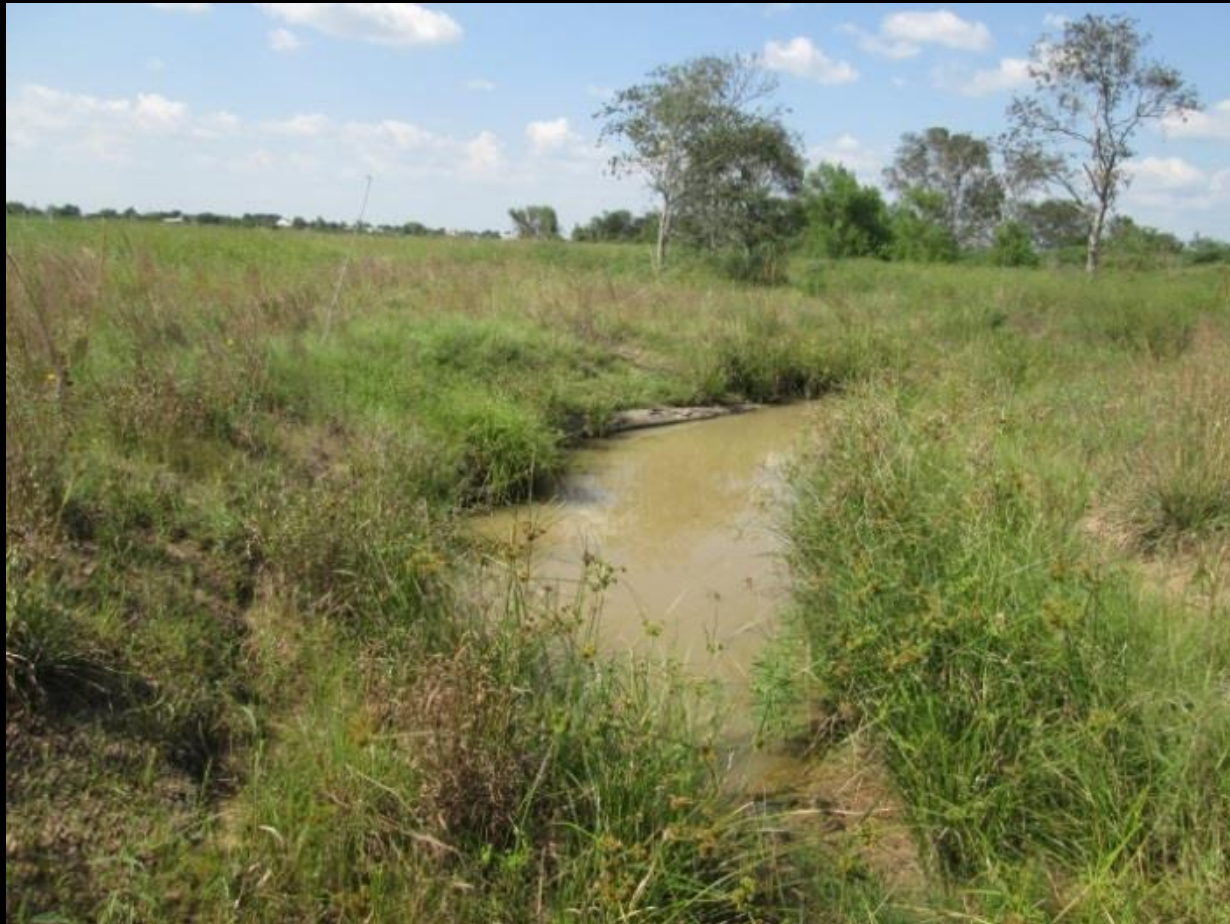
Photos Station 1 – 2015

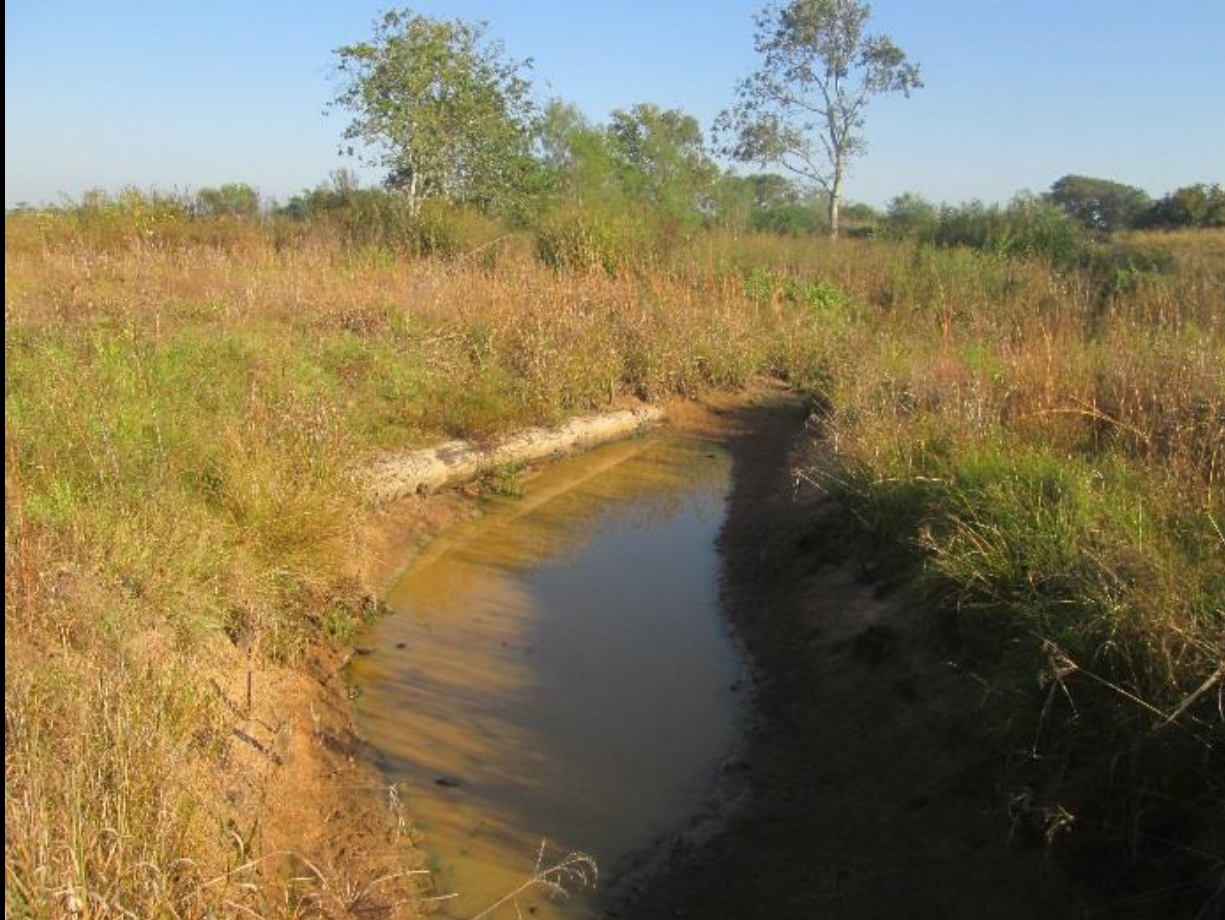
Photos Station 1 – 2016

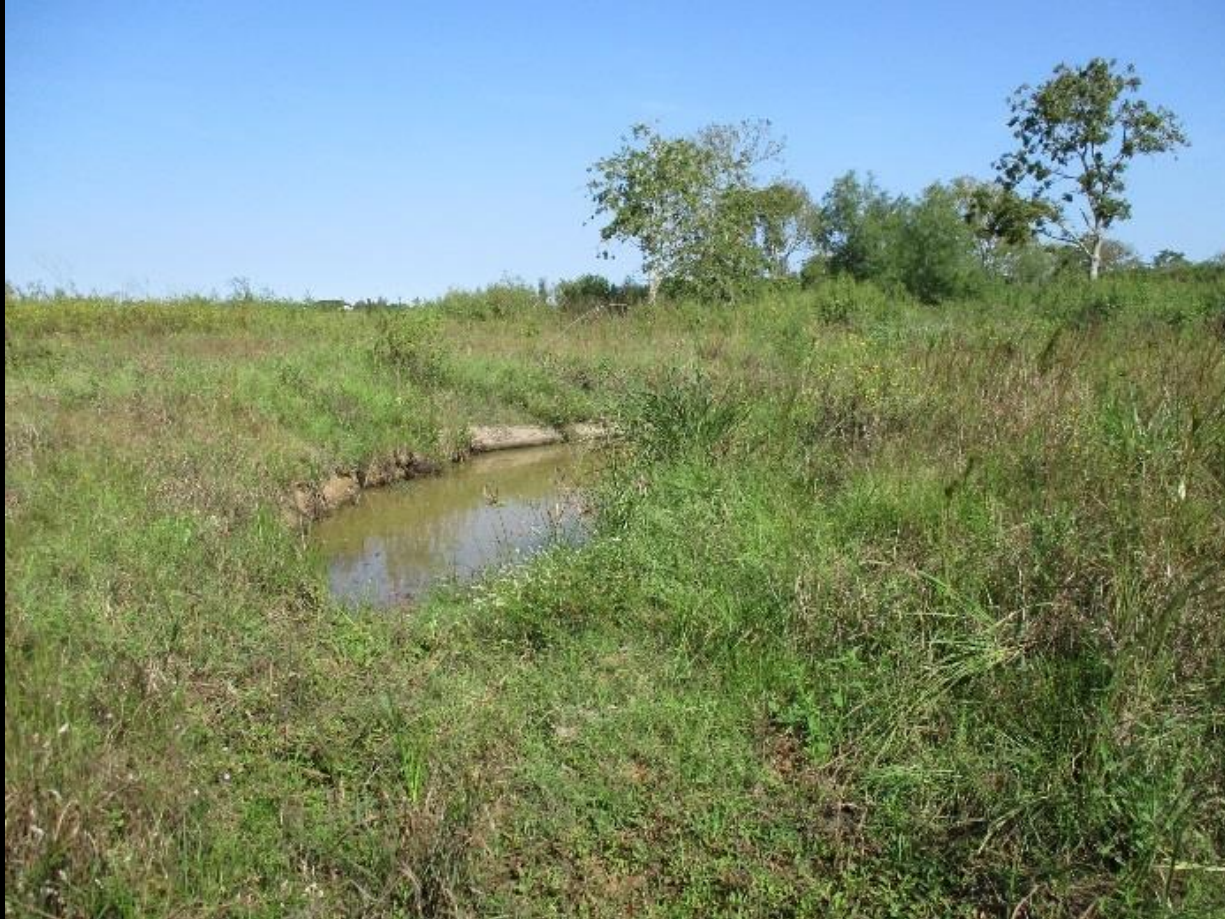
Photos Station 1 – 2017
